# Manhole Inspection Summary

Manhole # S37A2\_012MH

Insp Date: **12/6/07 8:01 AM**

**Location** Address: **3904 3rd St**

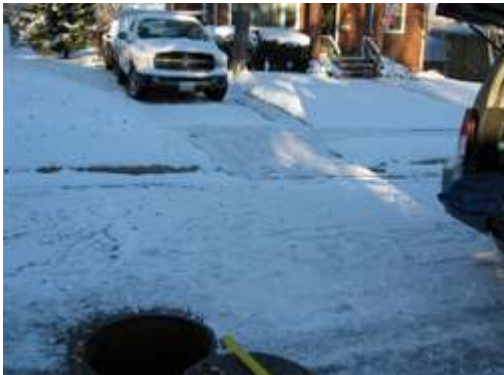
Location View

3904 3rd St

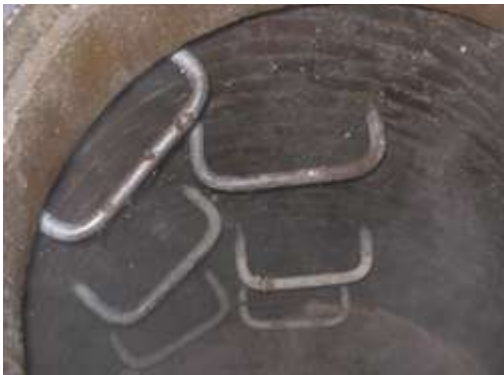
steps

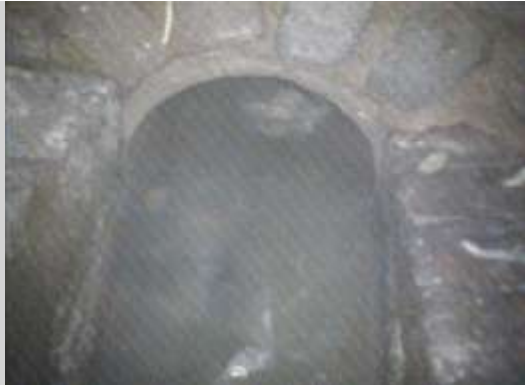
12 O'Clock Outflow

8 in. Circular Gravity Sewer  
Pipe Out @ 12 O'Clock

Pipe Height: **8.4** (in.) Rod and Bar (Angled)  
Pipe Material: **Clay** ☐ Pipe Lined  
Invert Depth: **9.40** (ft.) Flow Characteristics: **Fast**  
Deposits: ☒ None ☐ Mud ☐ Sludge ☐ Debris ☐ Grease  
Silt Depth: (in.) Deposits Extent:  
Infiltration: **None** Pipe Seal Cond: **Sound**

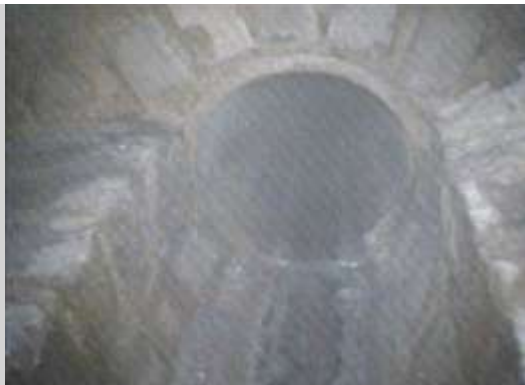
6 O'Clock Inflow

8 in. Circular Gravity Sewer  
Pipe In @ 6 O'Clock

Pipe Height: **8.4** (in.) Rod and Bar (Angled)  
Pipe Material: **Clay** ☐ Pipe Lined  
Invert Depth: **9.00** (ft.) Flow Characteristics: **Fast**  
Deposits: ☒ None ☐ Mud ☐ Sludge ☐ Debris ☐ Grease  
Silt Depth: (in.) Deposits Extent:  
Infiltration: **None** Pipe Seal Cond: **Sound**
